Memorandum

To: Mike Zimmerman
EPA-OSC
From: Mike Sullivan
TAT Region 8
Date: 8/6/92
Subject: Inspection of the Tailings Dam at Richardson Flats T08-9204-015.

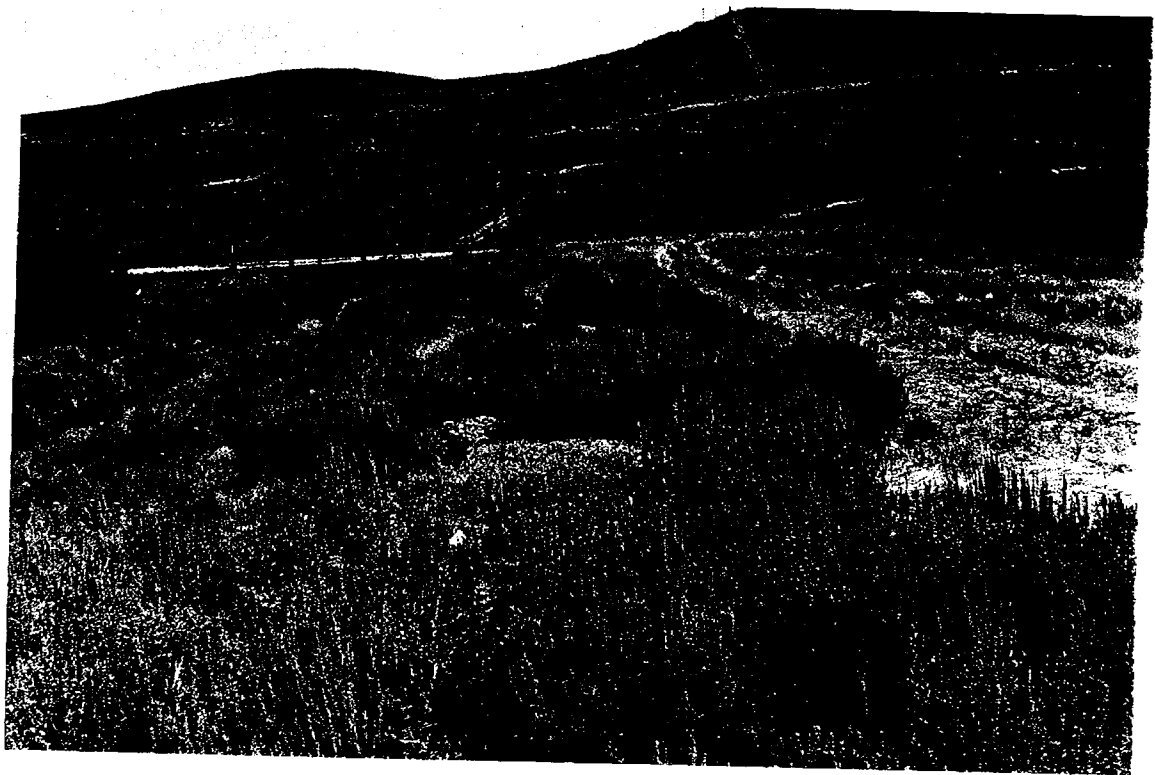
The crest is sloped back toward the tailings pond allowing any water to drain back to the tailings pond. However, small erosional gullies are forming on the crest and downstream face of the dam and could eventually lead to larger gullying on the dam.

Subject: Crest of main embankment from south corner

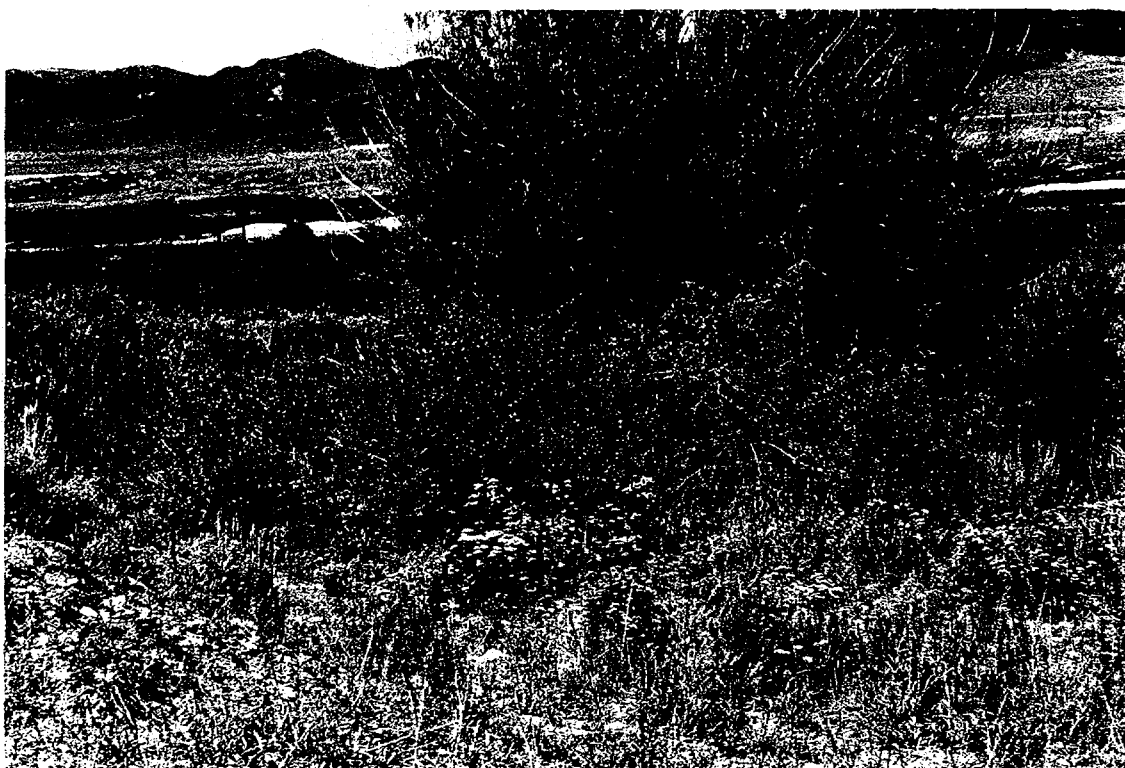
Rank vegetation, in the form of willows and trees, is growing at the toe of the dam. Approximately 8" of loamy damp soils are evident on the toe of the dam. The amount of vegetation and the type of soils on the toe of the dam indicate that the area receives a lot of water. As the wet soils were noted approximately 6 to 8 feet above the stream level this water is probably due to seepage under the dam. Other evidence of seepage from the toe of the dam was evident in the form of; soft marshy areas, rank vegetation including willows, loamy soils, damp soils, and areas where water had been standing (although no standing water was observed on August 4th).

Subject: Heavily vegetated area on toe of main embankment

ditch and the perimeter diversion ditch should be restored. In the future, the slopes on the main embankment should be flattened to 2.0:1.0 or greater, and the toe drainage blanket should be installed to allow liquids to drain away from the embankment. A monitoring well should be installed on the top of the tailings pond next to the embankment to monitor the elevation of groundwater within the pond and at the embankment. With water level elevation data available for both upstream of the embankment and at the toe of the embankment better, evaluations of the stability of the structure can be made. If any seeps appear on the embankment they should be monitored for both quantity and quality. Seeps carrying a sediment load generally indicate that active undermining of the embankment may be occurring. Undesirable vegetation in the form of willows and trees should be removed from the embankment.

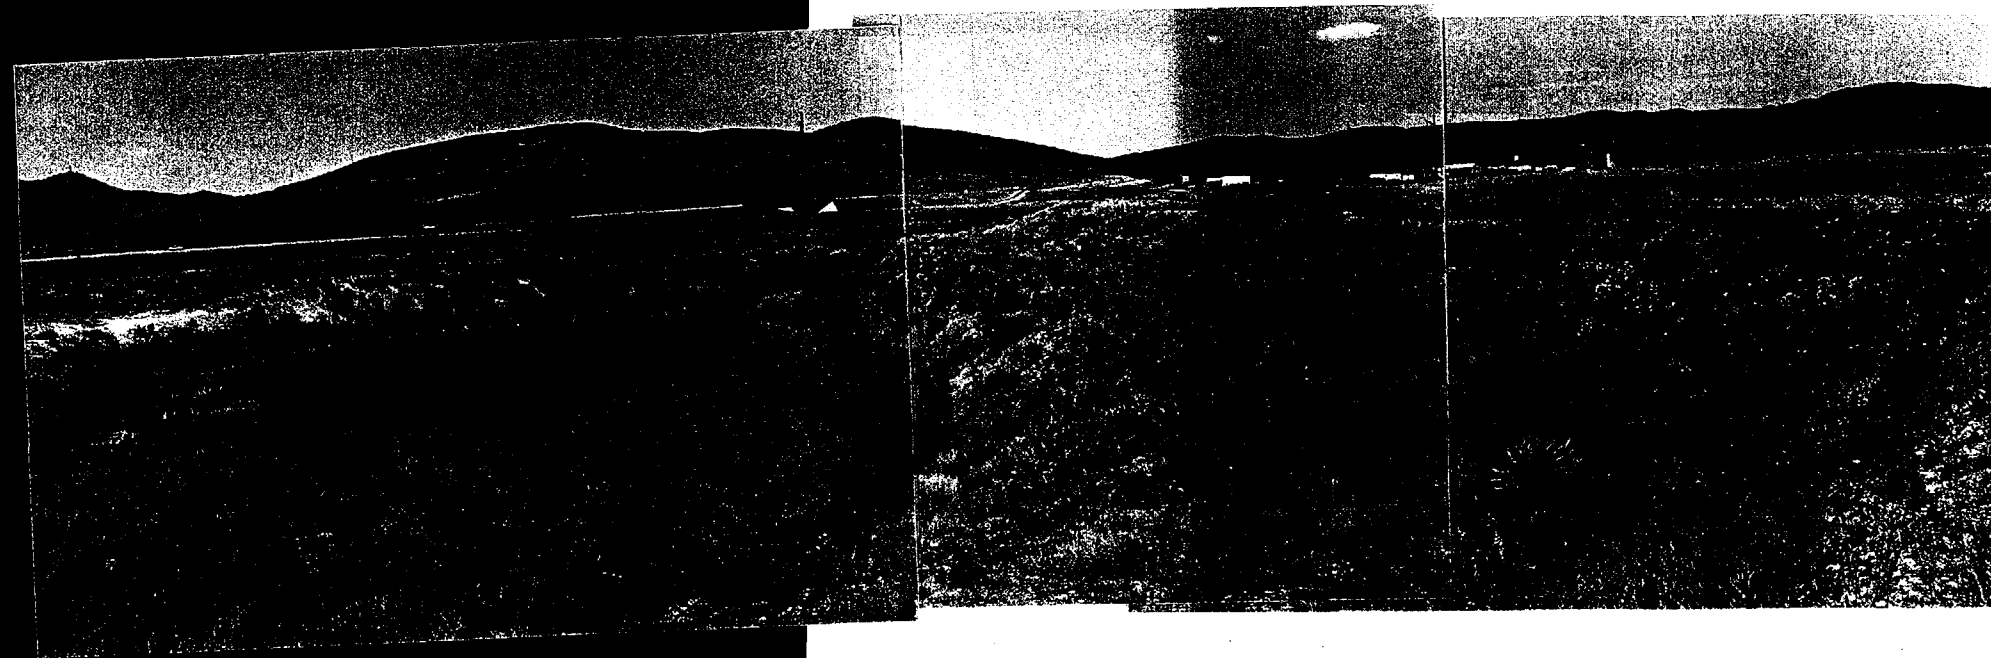
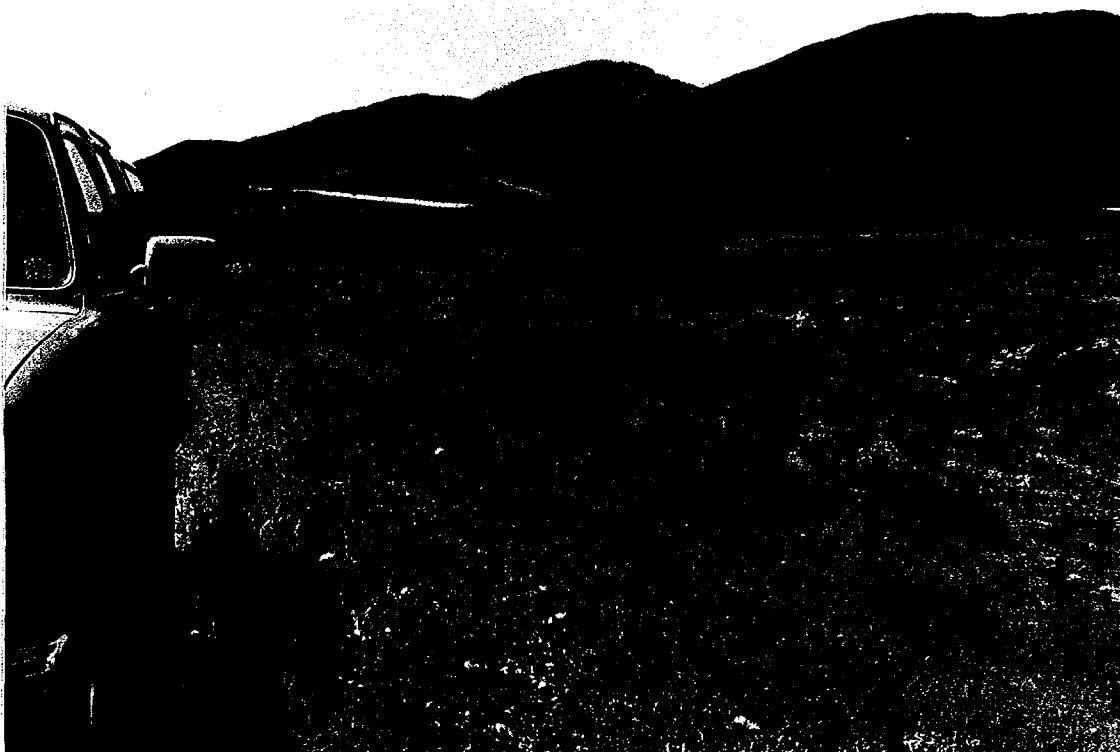
The perimeter dike was probably constructed by stripping materials off of the downstream side and piling the undifferentiated material up as a dike. The slopes are approximately 2.0:1.0. The dike is used as the access road for the pond and its elevation varies from 2 to 5 feet above the level of the tailings in the pond. The dike appears to be in good condition.

Subject: South embankment/dike and barrow pond looking west

Subject: South embankment/dike from barrow pond looking east
